N40085-09-B-0416
General Building Asbestos Removal
9M014CN

General Intent:

The intent of this project is to safely remove asbestos containing materials from the specific buildings listed below in the project area descriptions.

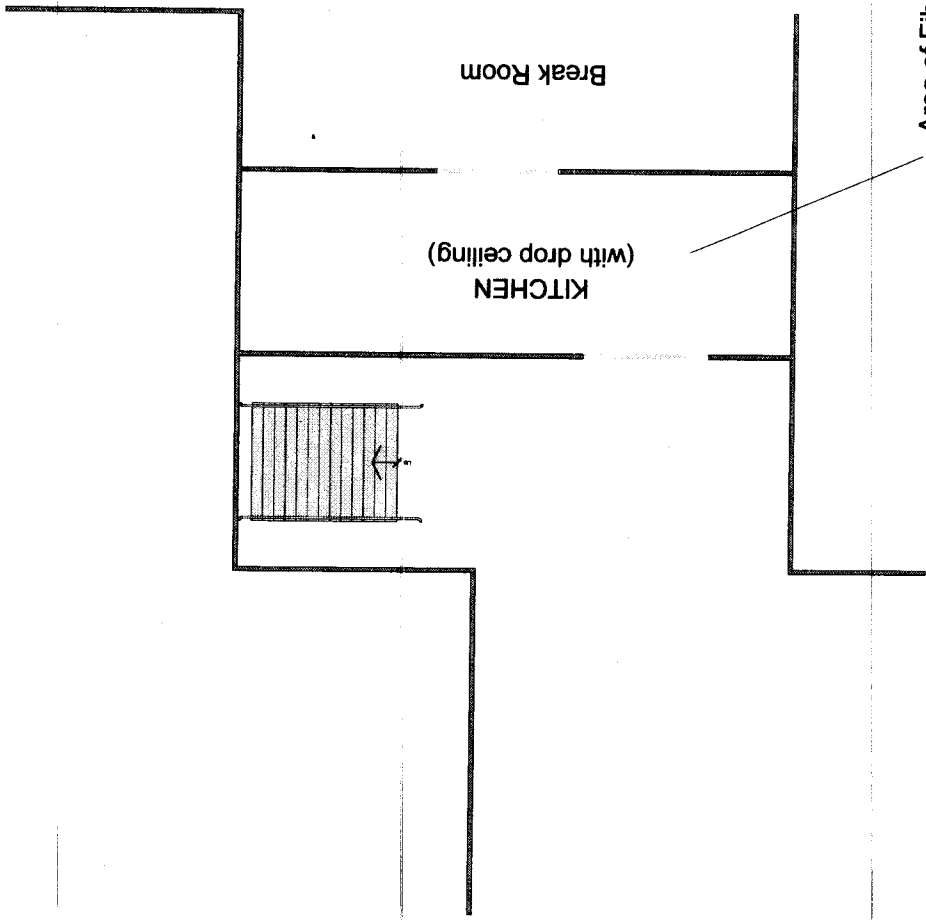
BUILDING 33
"AREA OF ASBESTOS"

Area of Fibrous Debris above
Drop Ceiling

- 1) Building 33 is an administrative office located at 33 Holcomb Blvd. There is fibrous ACM dust debris in the kitchen area above the drop ceiling involving approximately a 75 square foot area. Remove and dispose all asbestos containing material and replace approximately 75 S.F. of old ceiling tiles with new ceiling tiles.

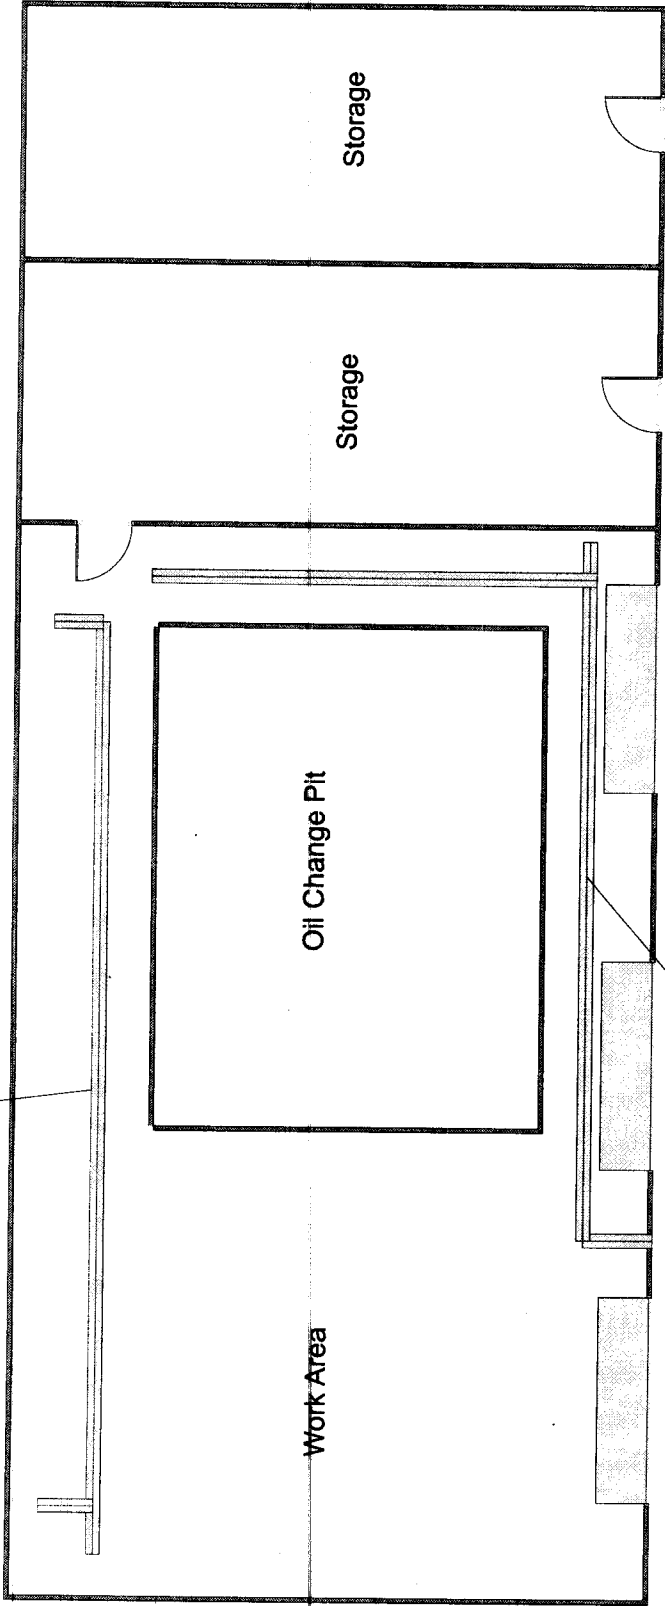
BUILDING 1111
"AREA OF ASBESTOS"

Location of 1-1/2" Pipe
Insulation with Asbestos

Location of 1/2" & 3/4"
Pipe Insulation with
Asbestos

= Pipe Insulation

- 2) Building 1111 is a general storage shed located at 1111 West Rd. Remove and dispose of all asbestos containing insulation and replace with new insulation on potable water piping and steam condensate piping shown on attached drawing. There is approximately 130 L.F. of 1/2", 3/4", 1-1/2" piping insulation. The piping insulation is identified with a red diamond danger sticker.

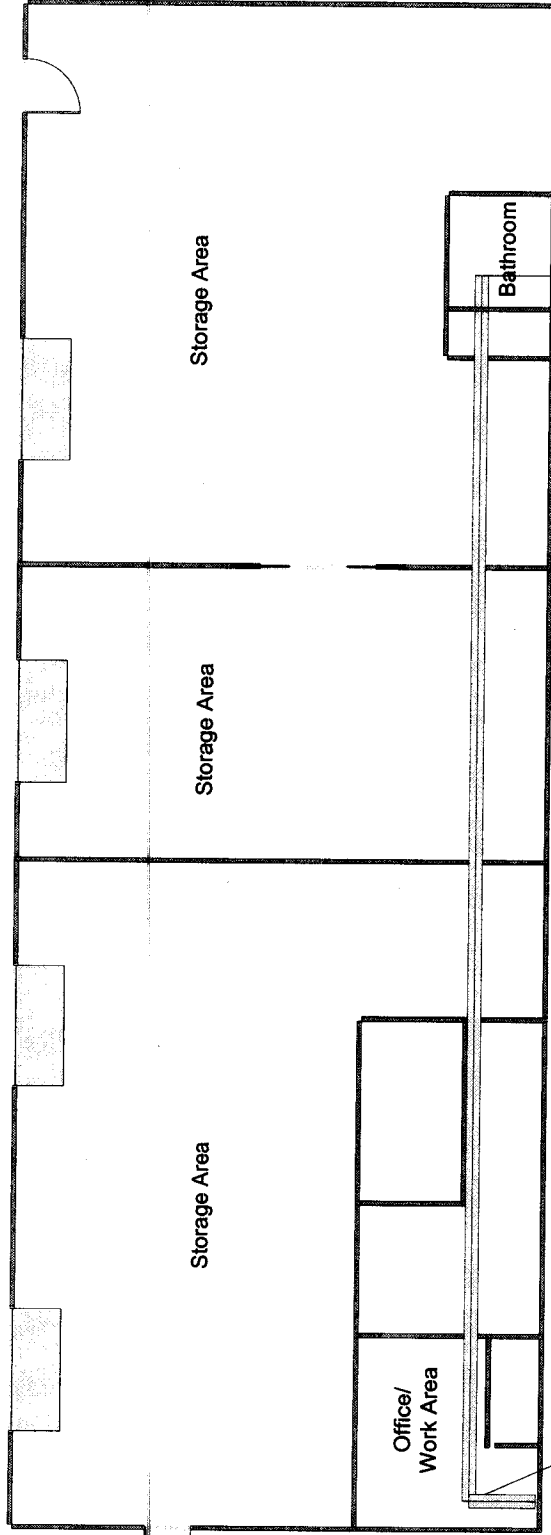
BUILDING 1203

Asbestos Containing
Pipe Insulation Located Above
Rafters and Walls

Asbestos Containing
Pipe Insulation Located Above
Rafters and Along Walls

- 3) Building 1203 is a general warehouse located at 1203 Cedar St. Remove and dispose of all asbestos containing insulation and replace with new insulation on water piping shown on the attached drawing. The pipe insulation is marked with danger stickers. There is approximately 130 L.F. of piping insulation. The point of contact to enter the building is James Smith 910-451-2131.

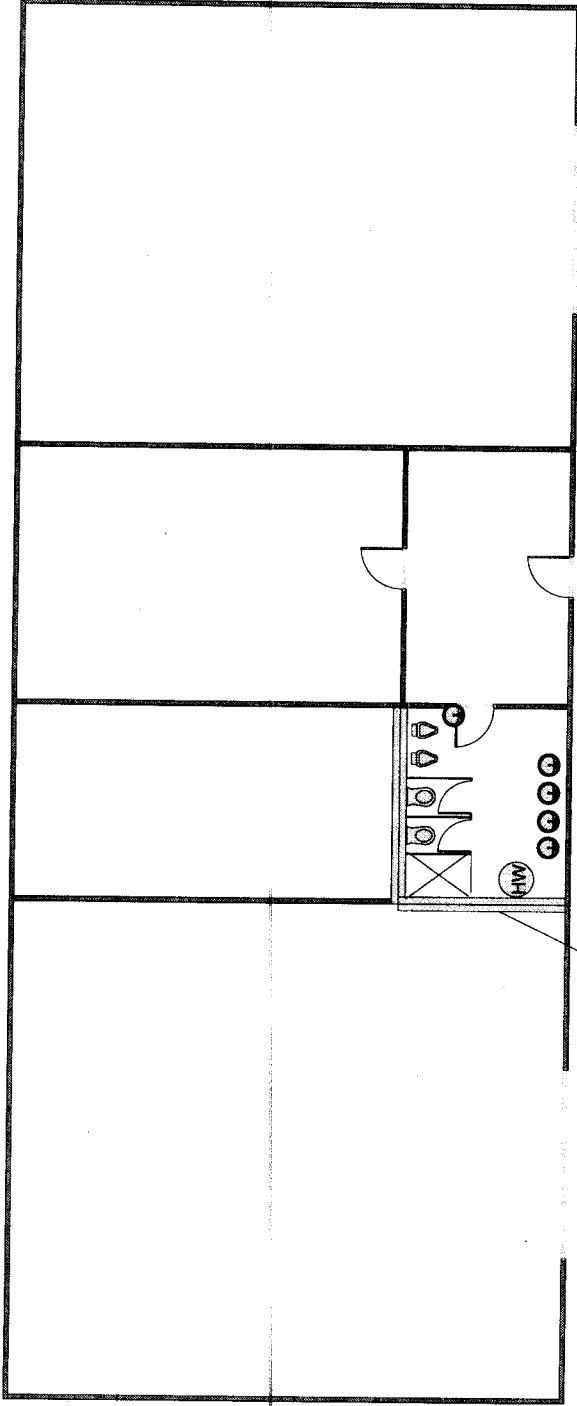
BUILDING 1505
"AREA OF ASBESTOS"

Bathroom Area with Pipe
Insulation with Asbestos

= Pipe Insulation

- 4) Building 1505 is a warehouse facility located at 1505 Elm St. Remove and dispose all asbestos containing piping insulation and replace with new insulation in the bathroom shown on the attached drawing. The potable water piping is located on the adjacent wall behind the water heater and behind the shower, toilets, and urinals and is marked with a danger sticker. There is approximately 60 L.F. of 1" and 2" piping insulation to be removed.

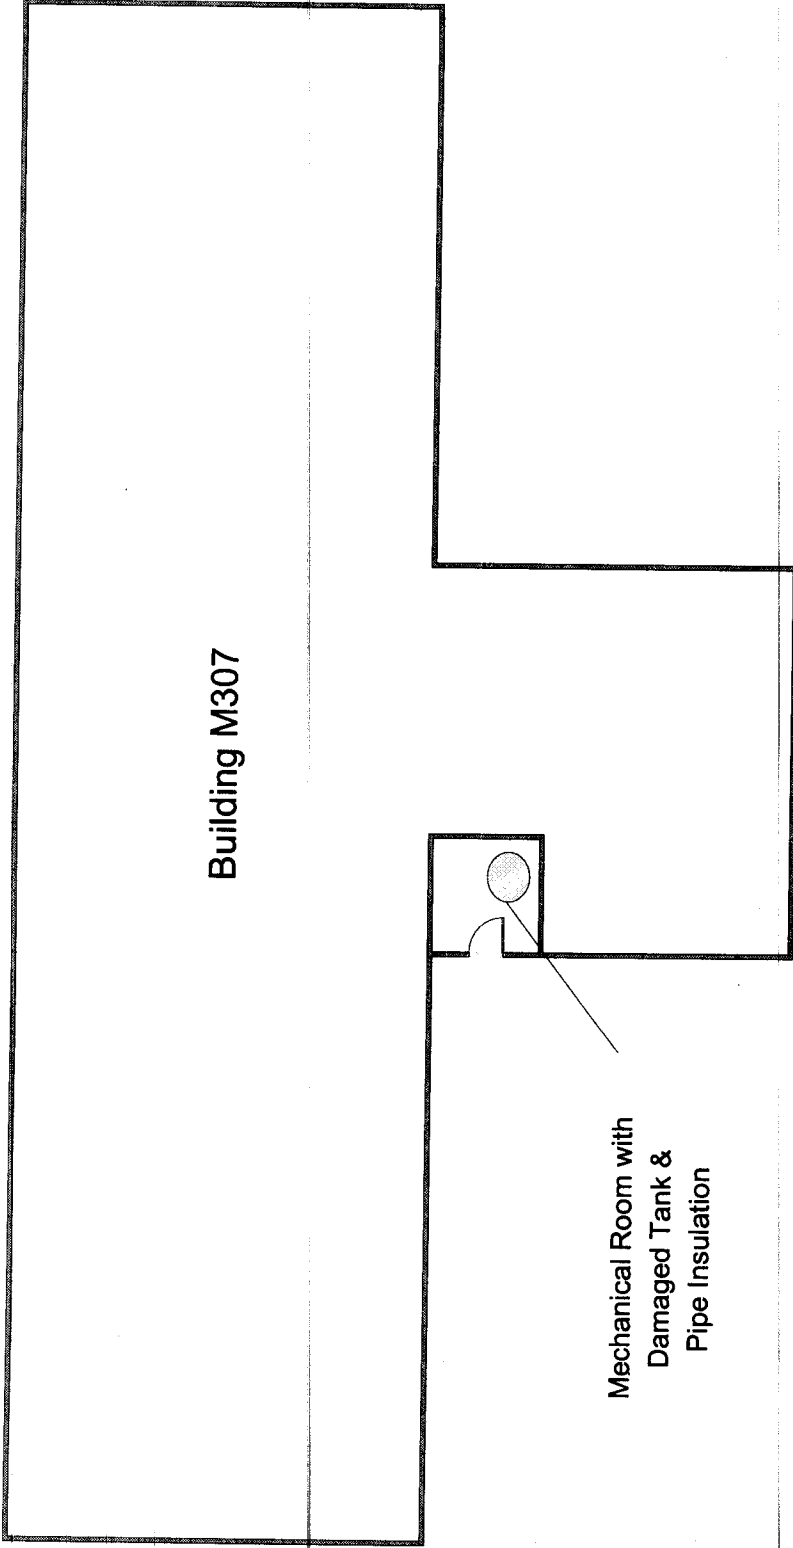
BUILDING M307
"AREA OF ASBESTOS"

Mechanical Room with
Damaged Tank &
Pipe Insulation

- 5) Building M307 is a classroom/chaplain's offices located at 307 Company B St. Remove and dispose of all asbestos containing tank and piping insulation and replace with new insulation as shown on the attached drawing. The insulation is located in the mechanical room and is marked with orange paint. There is approximately 75 S.F. of tank insulation and 2 L.F. of piping insulation.

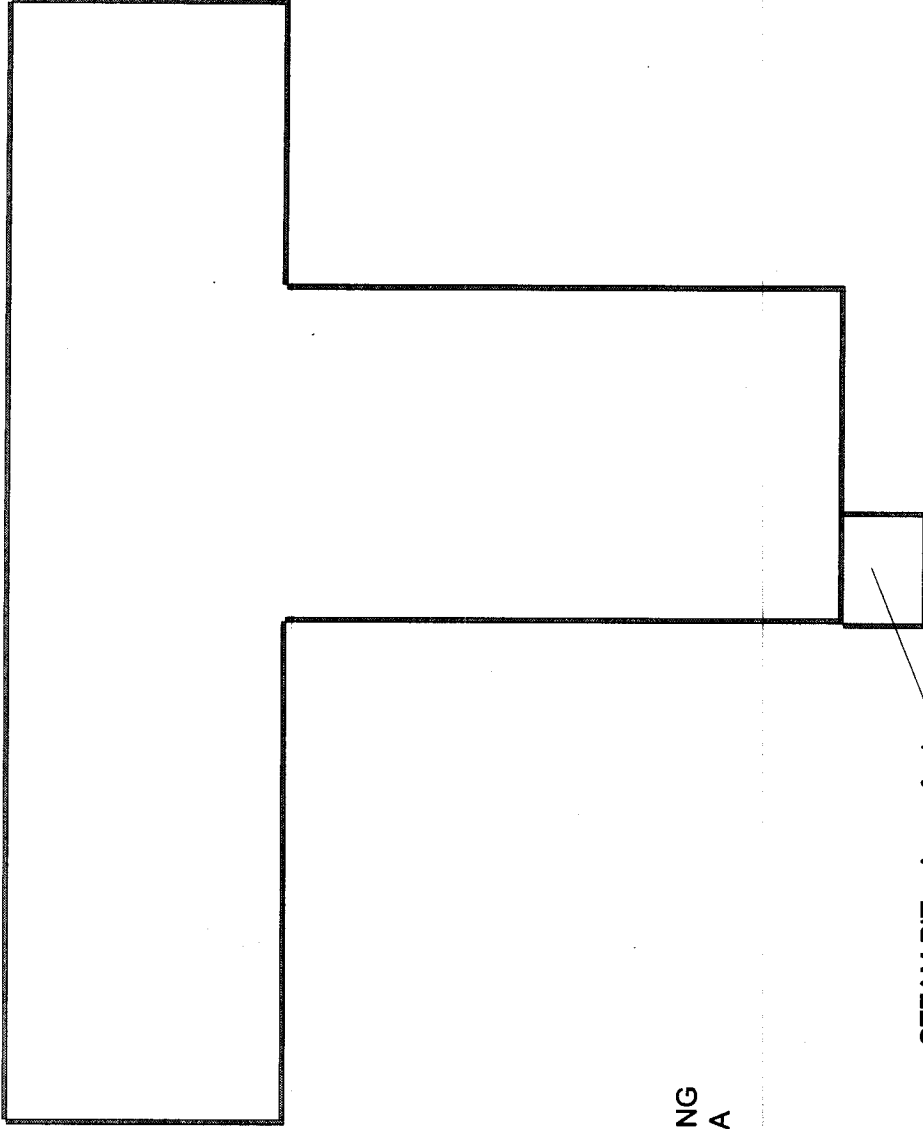
BUILDING 13
"AREA OF ASBESTOS"

STEAM PIT - Area of pipe
insulation & mudded fittings
containing asbestos

- 6) Building 13 is an administrative office located at 13 McHugh Blvd. Remove and dispose of all asbestos containing insulation and replace with new insulation as shown on the attached drawing. The insulation is located in the steam pit and is marked with orange paint and danger signs. There is approximately 25 L.F. of piping insulation. The steam pit is considered a confined space and confined space guidelines must be followed.
